**РОССИЙСКИЙ МОРСКОЙ РЕГИСТР СУДОХОДСТВА**  
**RUSSIAN MARITIME REGISTER OF SHIPPING**

**ПРОЦЕДУРНЫЕ ТРЕБОВАНИЯ,  
УНИФИЦИРОВАННЫЕ ИНТЕРПРЕТАЦИИ  
И РЕКОМЕНДАЦИИ  
МЕЖДУНАРОДНОЙ АССОЦИАЦИИ  
КЛАССИФИКАЦИОННЫХ ОБЩЕСТВ**

**IACS PROCEDURAL REQUIREMENTS,  
UNIFIED INTERPRETATIONS  
AND RECOMMENDATIONS**

НД № 2-020101-099-R-E

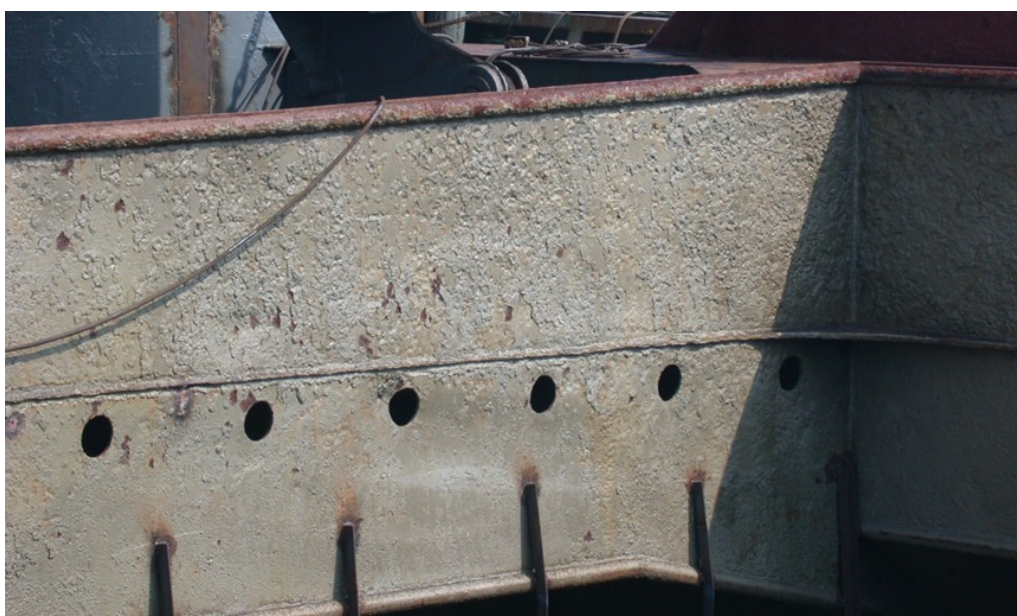
**Photograph 1 Heavy corrosion of hatch coaming**

**3.1.2** Severe corrosion of the hatch coaming from inside and of under deck girders may occur due to difficult access for maintenance of the protective coating. This may in turn lead to fractures (See **Photograph 1**).

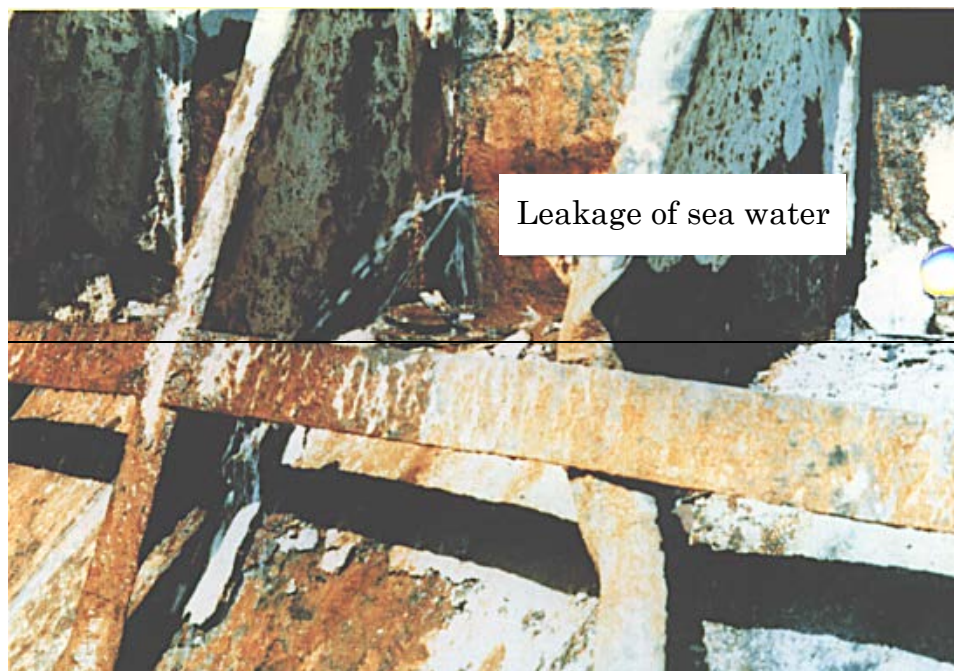
**Photograph 1**      Leakage from side shell plating due to heavy corrosion

| Figures and/or Photographs - Area 2 | |
|---|---|
| Photograph 1 | Leakage from side shell plating due to heavy corrosion |

- 1.6 A summary of potential problem areas is shown in **Figures 1 (a) and (b)**. Serious consequences of damaged ship sides are illustrated in **Photographs 1 and 2**.

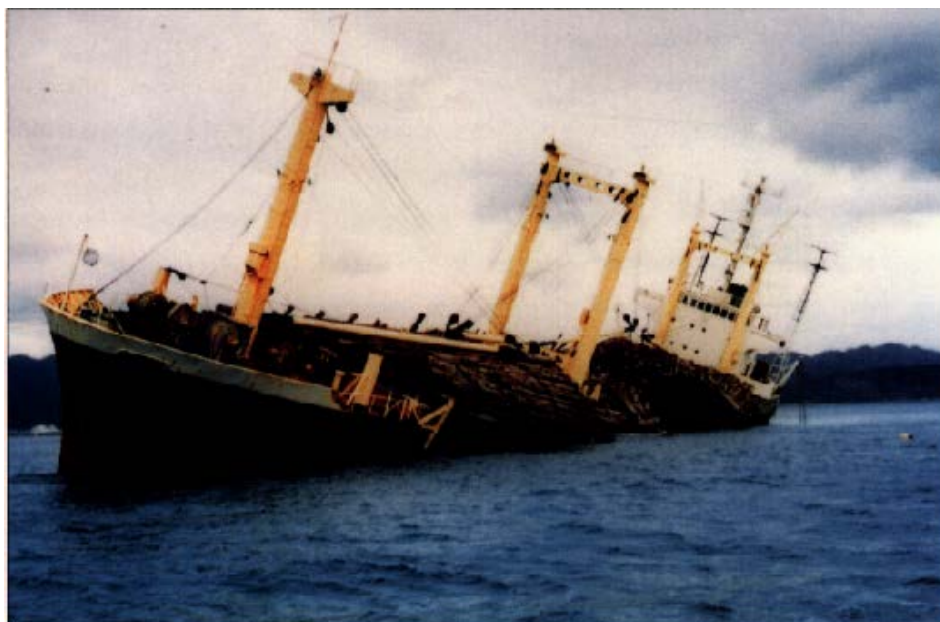
**Photograph 2**      Timber carrier listing due to ingress of water

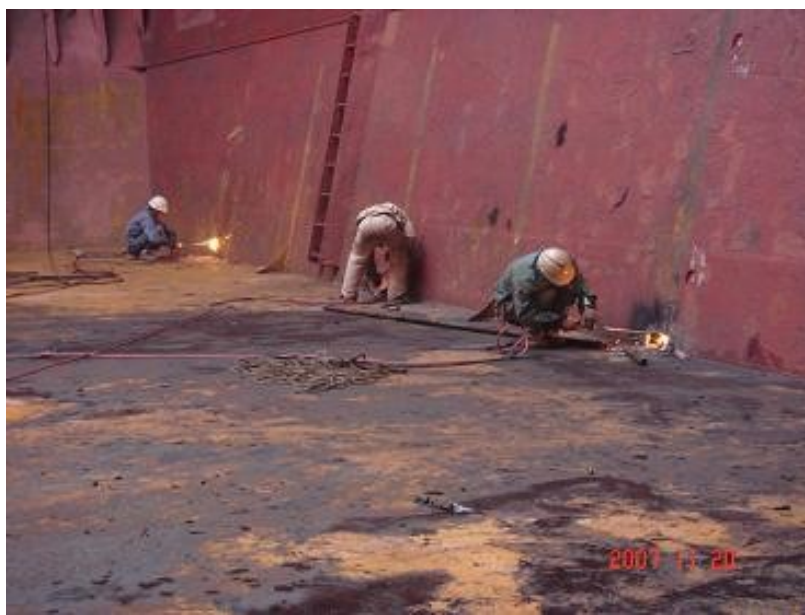
**Photograph 1 Heavy corrosion affecting inner bottom plating**

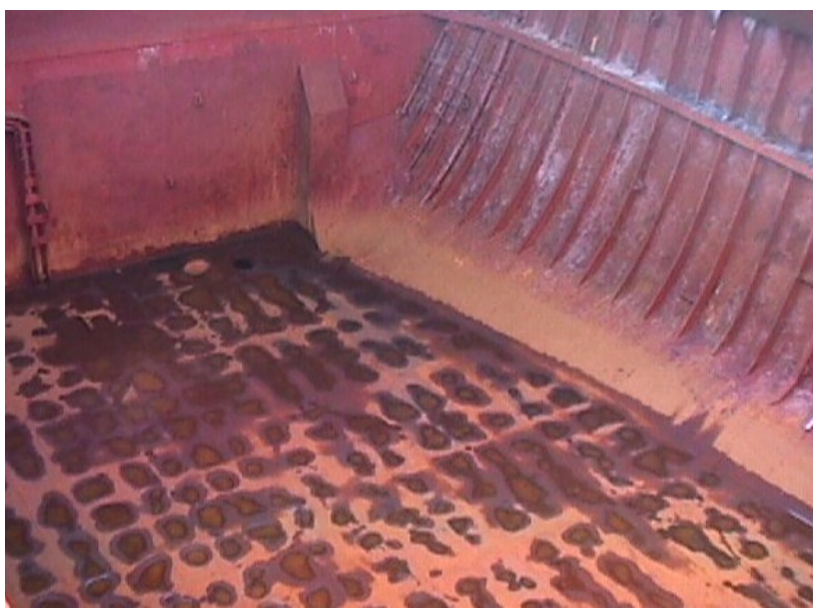
**Photograph 2 Damaged inner bottom plating**

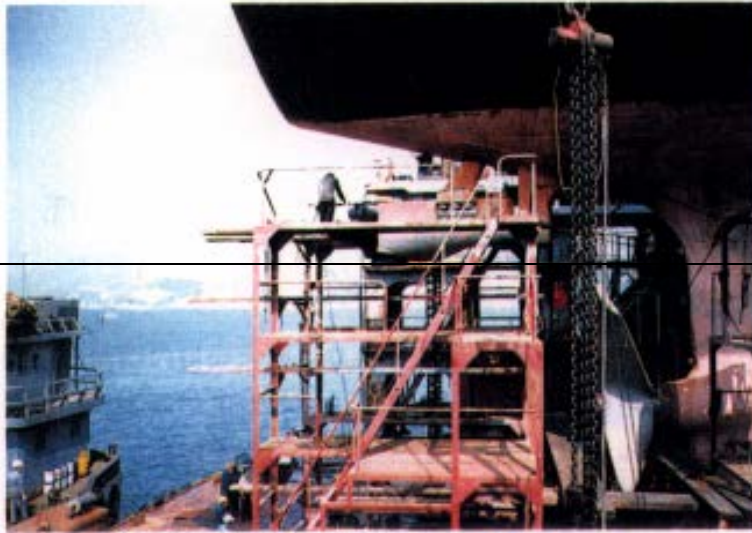
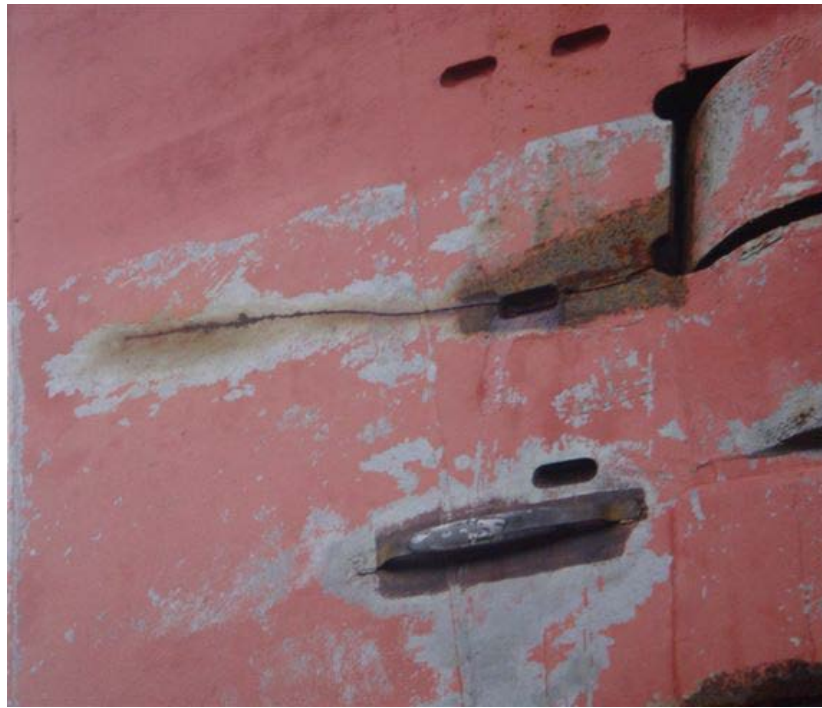
**Photograph 1**  
**Fractured rudder due to corrosion in rudder plating**

Corrosion/erosion (such as deep pitting corrosion) should be looked for in rudder/rudder horn, especially in welds. In extreme cases the corrosion /erosion may cause a large fracture as shown in **Photograph 1**.

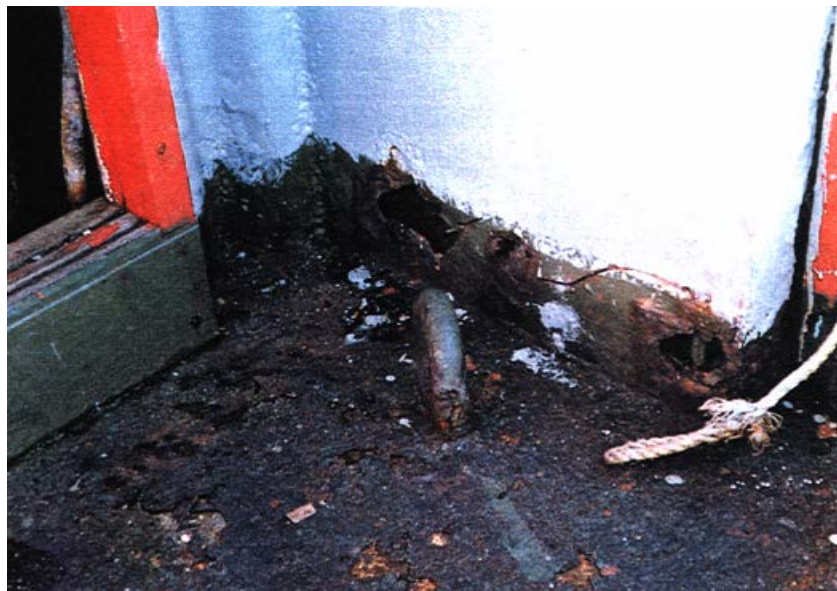
**Photograph 1**      **Corroded accommodation house structure**

The main damage is corrosion which may cause serious problems since the structure is relatively thin. Serious corrosion may be found in exposed deck plating and its adjoining accommodation house structure where water is liable to collect (See **Photograph 1**). Corrosion is also found in accommodation bulkheads where fittings such as doors, side scuttles, ventilators, etc. are fitted and proper maintenance of the area is relatively difficult. Deterioration of the bulkheads including fittings may impair the integrity of weathertightness.

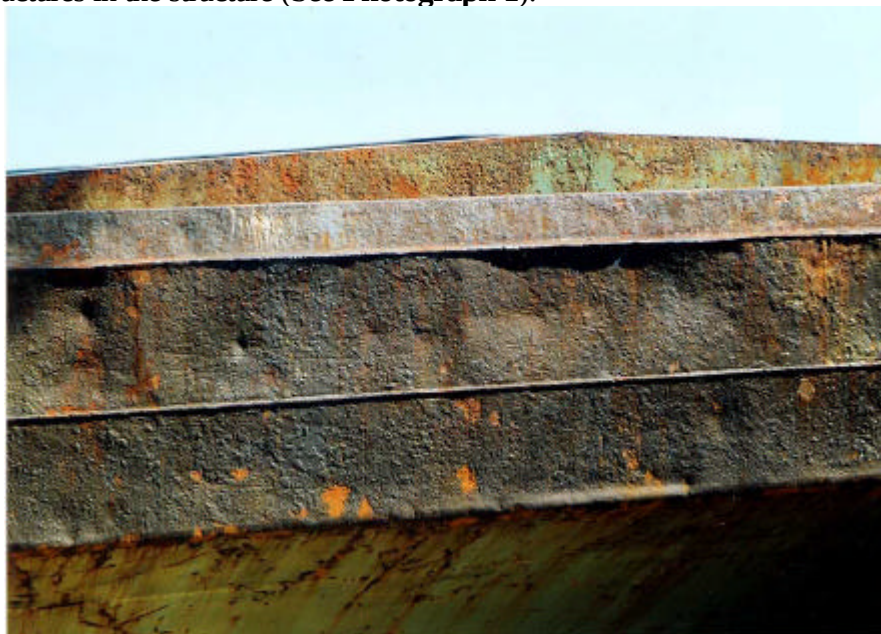
**Photograph 1**      **Heavy corrosion of hatch coaming and topside tank plating vertical strake**

- 3.1.1 The level of wastage of under-deck stiffeners/structure in cross deck may have to be established by means of thickness measurements. The combined effect of the marine environment and the high humidity atmosphere within cargo hold s will give rise to a high corrosion rate.
- 3.1.2 Severe corrosion of the hatch coaming plating inside cargo hold and topside tank plating vertical strake may occur due to difficult access for the maintenance of the protective coating. This may lead to fractures in the structure (See **Photograph 1**).

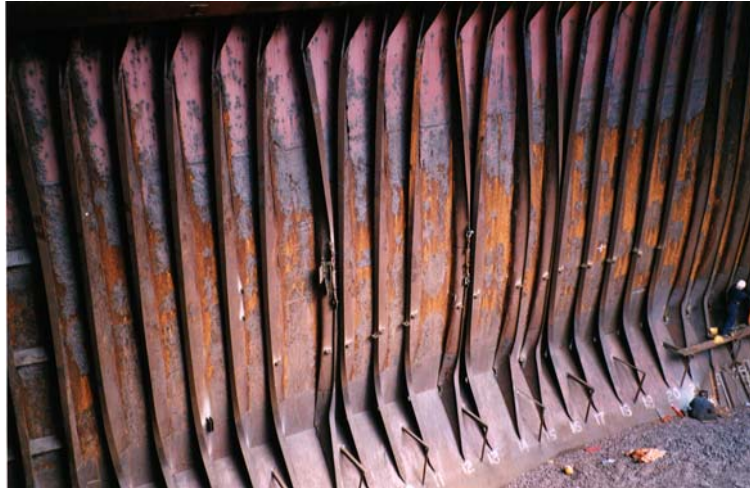
**Photograph 1** Collapsed side shell frames (See Example 4)

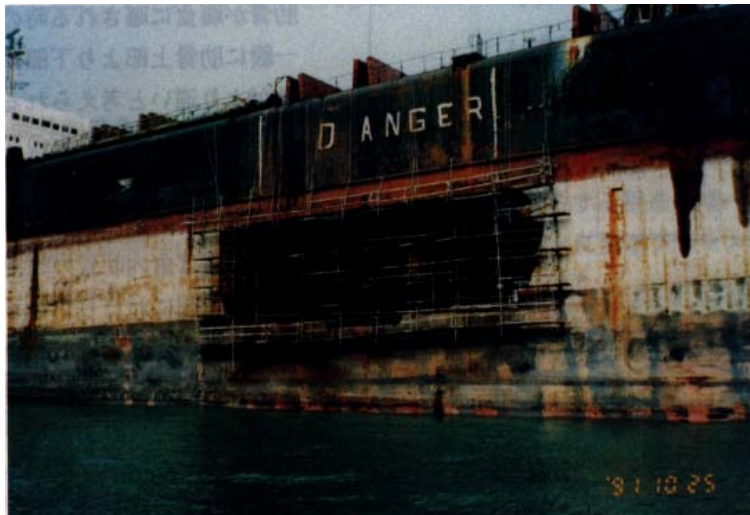
**Photograph 2** Missing side shell structure (See Examples 4 and 5)

| <b>Figures and/or Photographs - Area 3</b> | |
|---|---|
| Photograph 2 | Missing side shell structure |

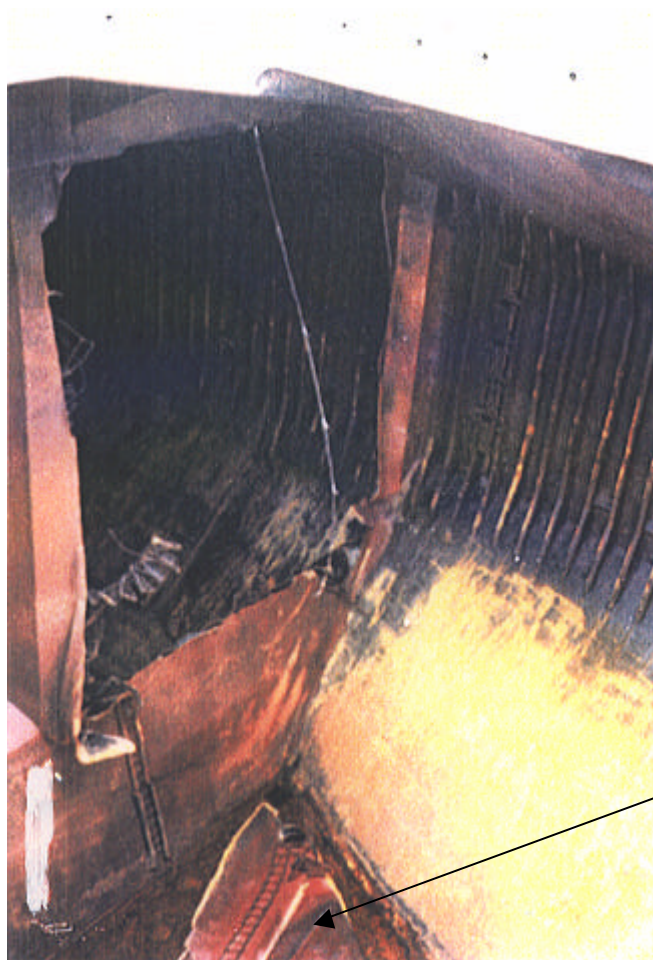
**Photograph 1**  
**Collapsed and detached**  
**transverse bulkhead**

Collapsed and detached transverse bulkhead on the tank top

- 1.4** Dry cargo holds, not designed as ballast holds, may sometimes be partially filled with water ballast in order to achieve a satisfactory air draught at the loading/discharging berths.  
The filling is restricted to a level that corresponds to the dry cargo hold scantlings, in particular the transverse bulkheads scantlings, and must only be carried out in port. In no case should these cargo holds be partially filled during voyage to save time at the berth. Such filling at sea may cause sloshing resulting in catastrophic failure such as indicated in **Photograph 1**.

- 1.5** Heavy corrosion may lead to collapse of the structure under extreme load, such as indicated in **Photograph 1** if it is not rectified properly.

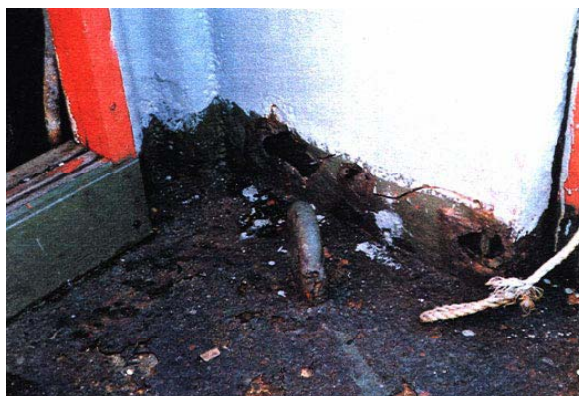
**Photograph 1 Corroded accommodation house side structure**

Severe corrosion may be found in exposed deck plating and deck house side structure adjacent to the deck plating where water is liable to accumulate (See **Photograph 1**). Corrosion may also be found in accommodation bulkheads around cut-out for fittings, such as doors, side scuttles, ventilators, etc., where proper maintenance of the area is relatively difficult. Deterioration of the bulkheads including fittings may impair the integrity of weathertightness.
